# **HIGH ALTITUDE REVEGETATION WORKSHOP**

**NO. 19**

**Colorado State University  
Fort Collins, Colorado  
March 2-4, 2010**

Information Series No. 113  
Colorado Water Resources Research Institute  
Colorado State University

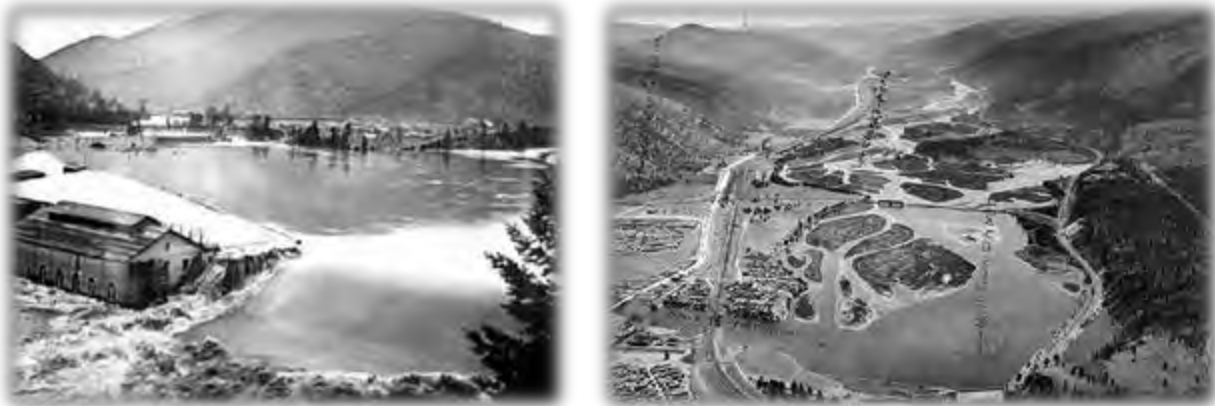
**Figure 1.** 1908 flood photograph at left, 1935 flood photograph on right.

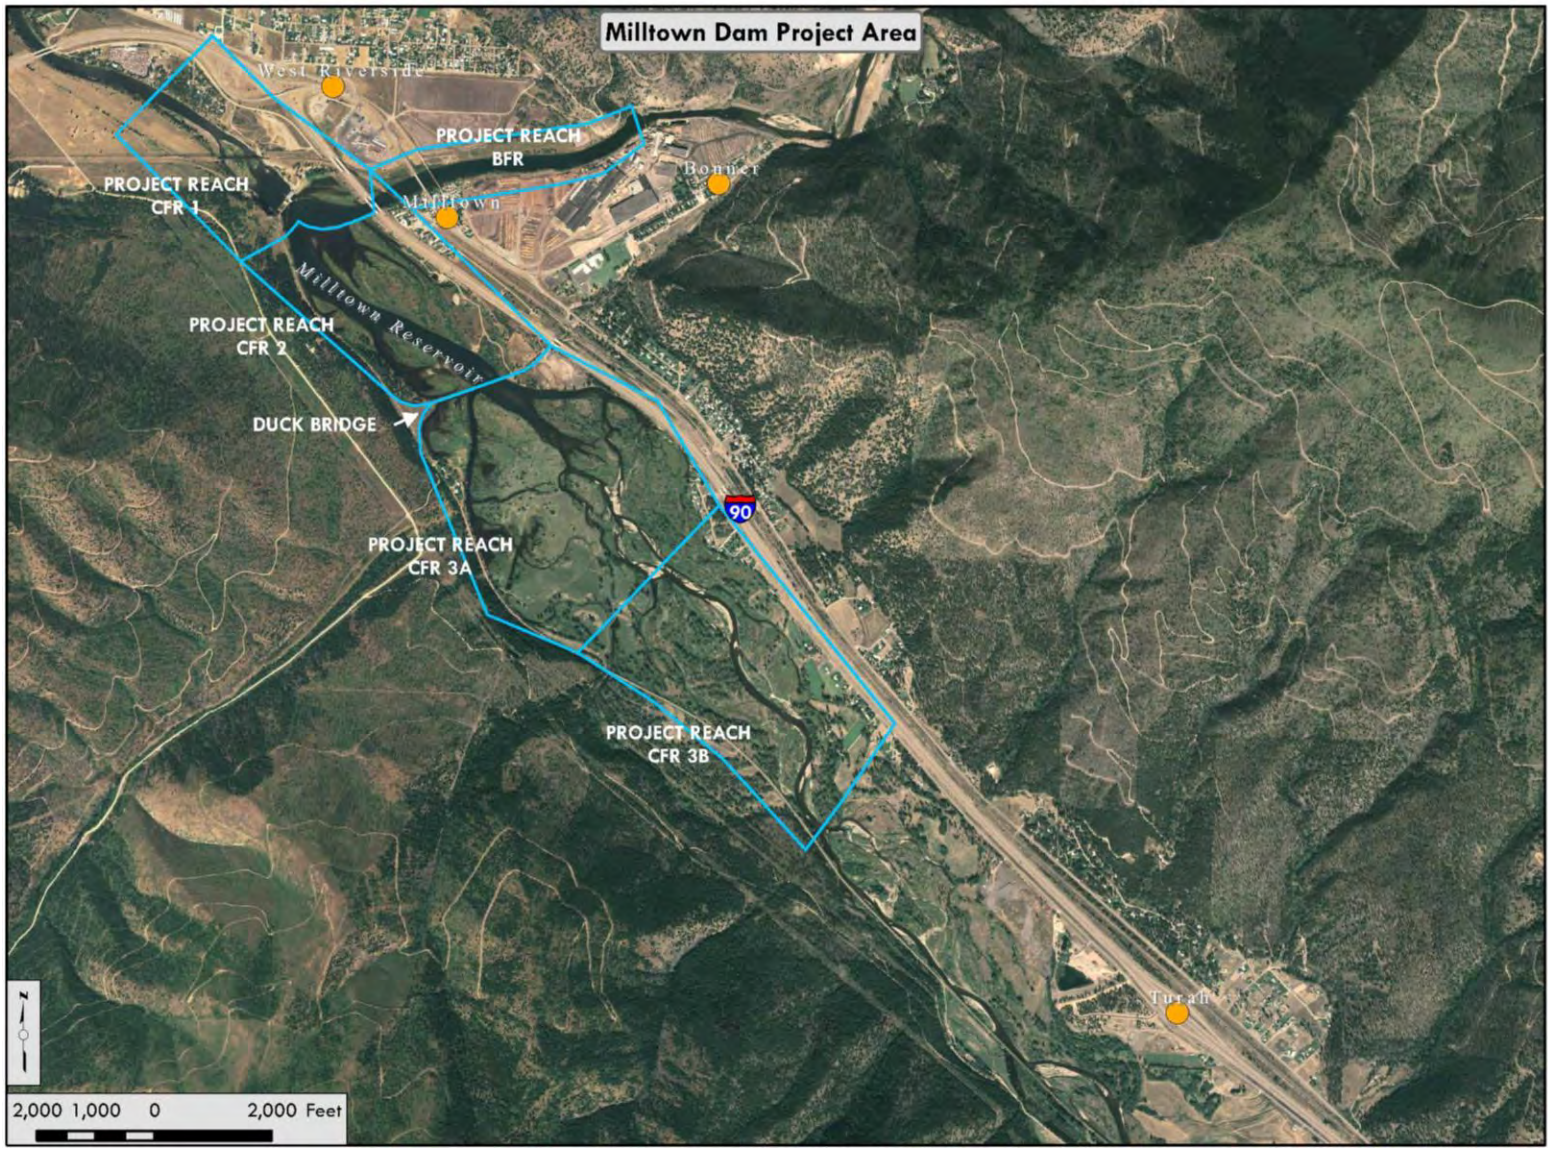
Figure 2. Overview figure showing the Milltown restoration area and project reach breaks.

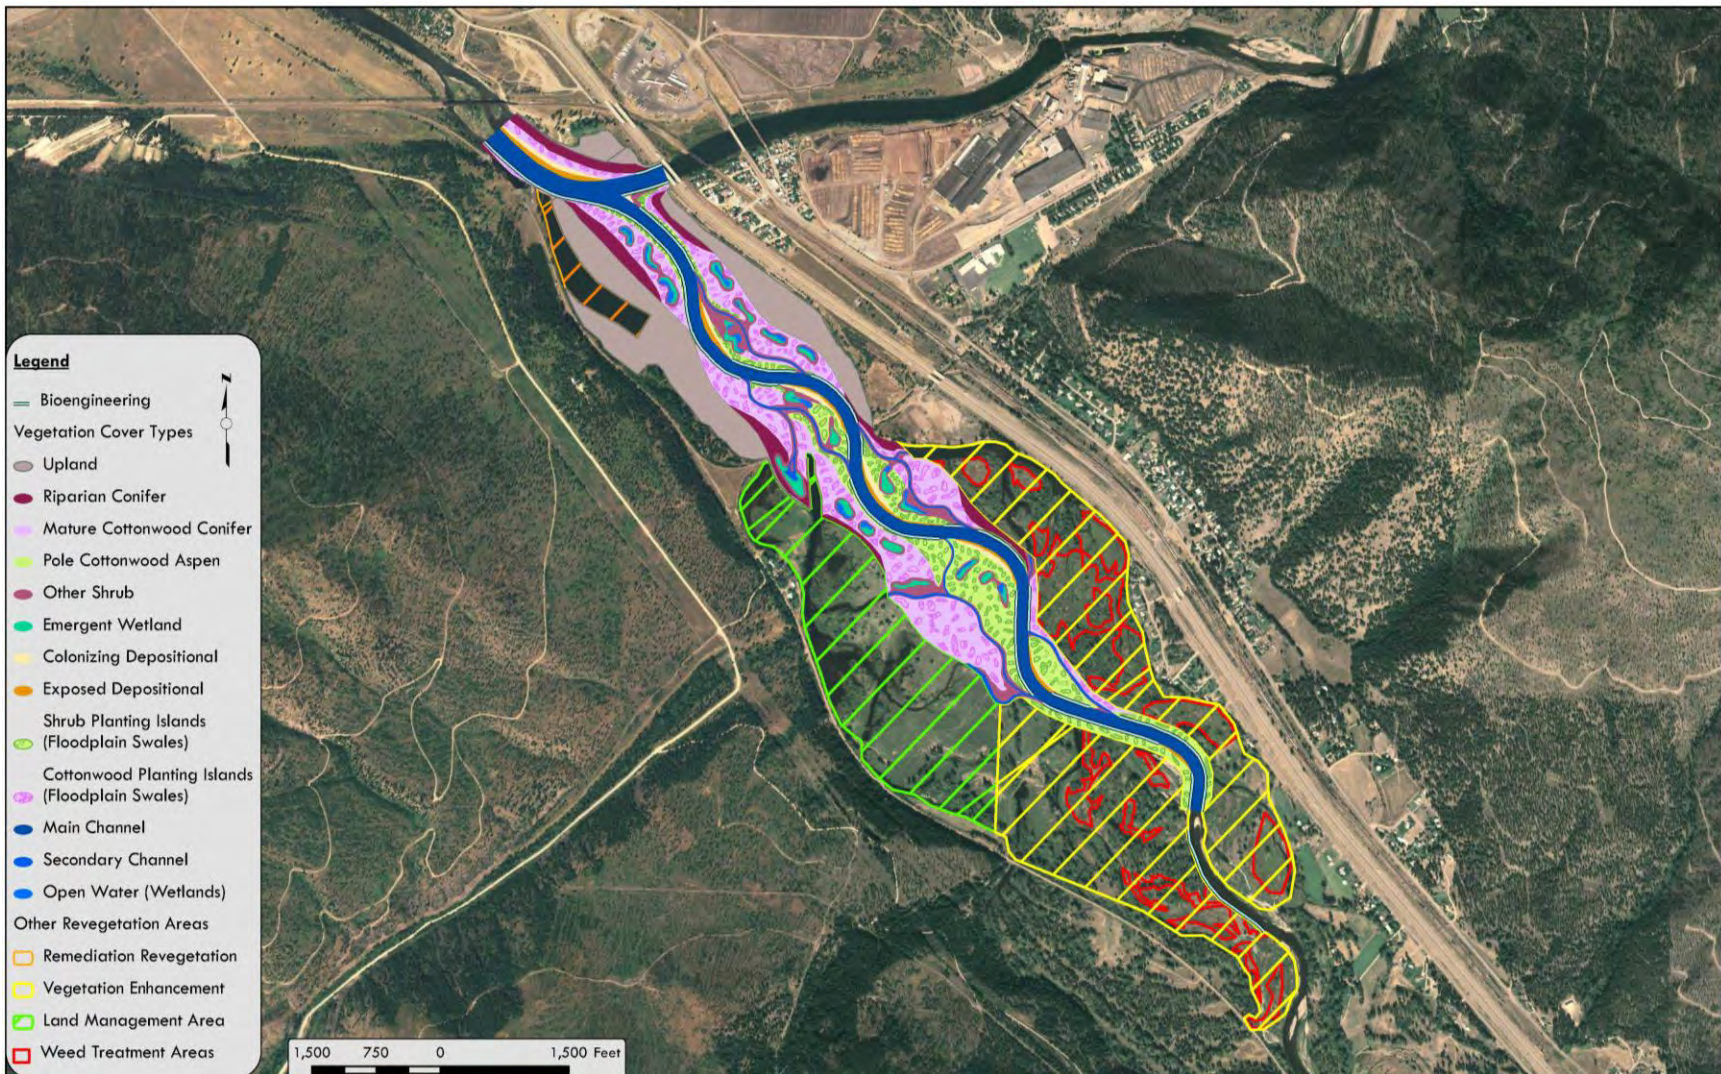
**Figure 3.** Design floodplain vegetation cover types and restoration areas for the Clark Fork River near Milltown Dam.

The mature cottonwood and conifer cover type includes mature conifer, cottonwood and aspen stands. This cover type occurs in areas corresponding to the existing low terrace elevation observed in the restoration area, where floods would occur at frequencies of ten years or greater. The time frame for developing mature vegetation on this surface is 15 to 25 years after floodplain construction. In general, this cover type will not support wetlands although small areas of wetland may persist in low elevation swales.

This cover type includes mature conifer communities with a mix of riparian shrubs and upland shrubs such as chokecherry, mockorange, and serviceberry. The riparian conifer cover type, located between two and three feet above the bankfull elevation, is unlikely to be altered by flood events that occur at frequencies of 20 years or greater. Within this cover type, the dominant disturbance processes are less likely to be flood-related, and more likely to be caused by wind, fire, insects or disease. The time frame for developing mature conifers on this surface is 30 to 50 years after floodplain construction.

This cover type includes areas where the desired long-term plant community includes upland grassland or conifer communities within the restoration area. This cover type occurs on landform positions higher than those occupied by the riparian conifer cover type.

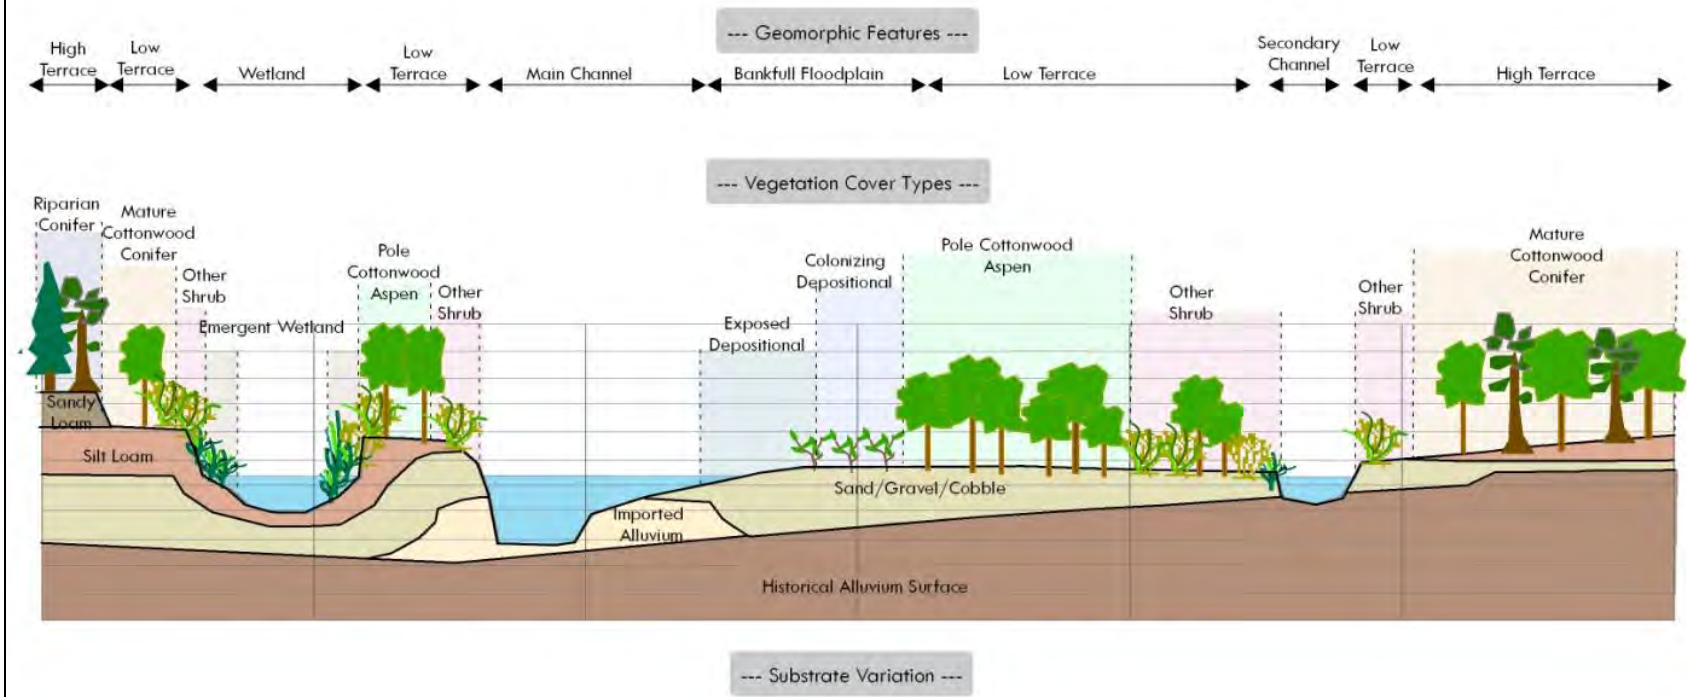
## Typical Cross-Section of Desired Future Condition

**Figure 4.** Typical cross section of the desired future condition for vegetation in relation to geomorphic features and substrates.

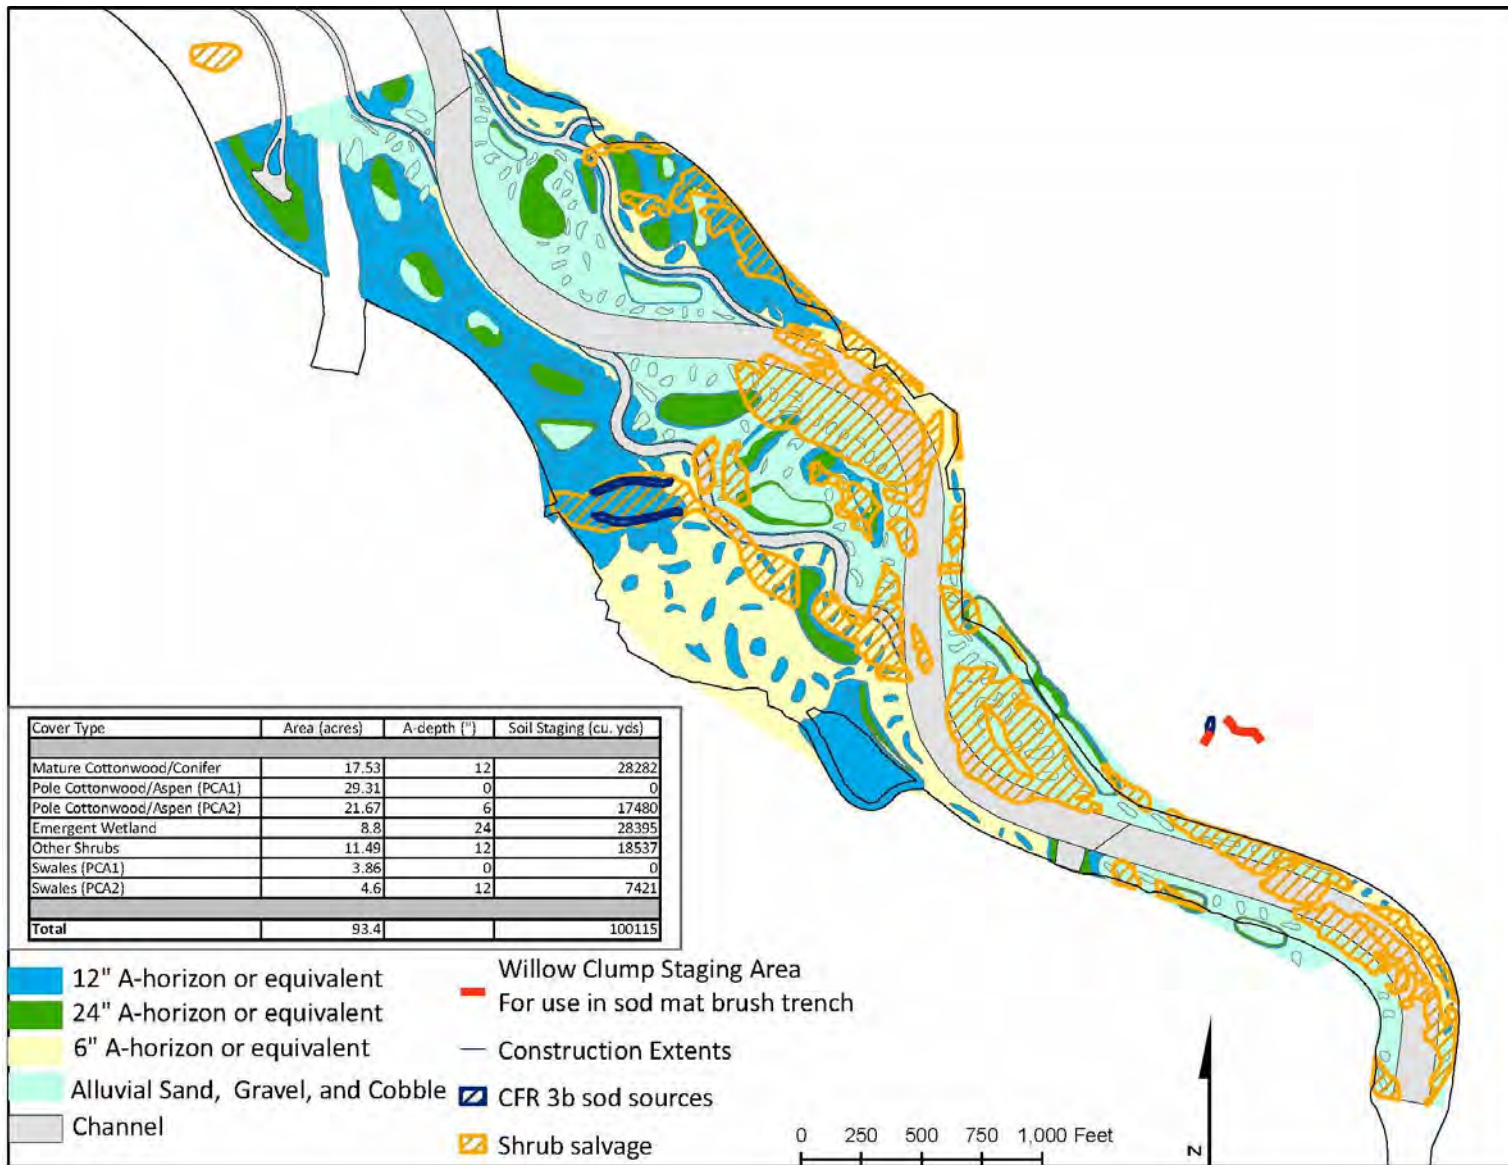
**Figure 8.** Shrub and sod salvage, staging areas, and substrate distribution.

Mature native shrubs and sod were salvaged from within construction limits for use in various revegetation techniques. Salvaged plants have the advantage of being adapted to site conditions, having mature and extensive root systems, and are mature enough to quickly add natural vegetation function to streambanks and floodplains once transplanted. Areas within construction limits with native sedge sod or willows were delineated for salvage. Figure 8 provides examples of plant salvage areas based on the vegetation community mapping completed during revegetation planning. Figure 8 also shows the substrate criteria for each cover type for a portion of the restoration area. Shrubs were salvaged from within construction limits both prior to construction and during construction. Prior to construction, shrubs were salvaged while dormant and staged out of the way of construction until they could be transplanted or incorporated as part of revegetation techniques such as sod brush trenches or planted on bankfull benches behind bioengineering structures (described below). Shrubs salvaged during construction were immediately transplanted into newly constructed wetlands and streambanks. Approximately two acres of wetland sod were salvaged and placed in a staging area for use in later project phases (Figure 9).

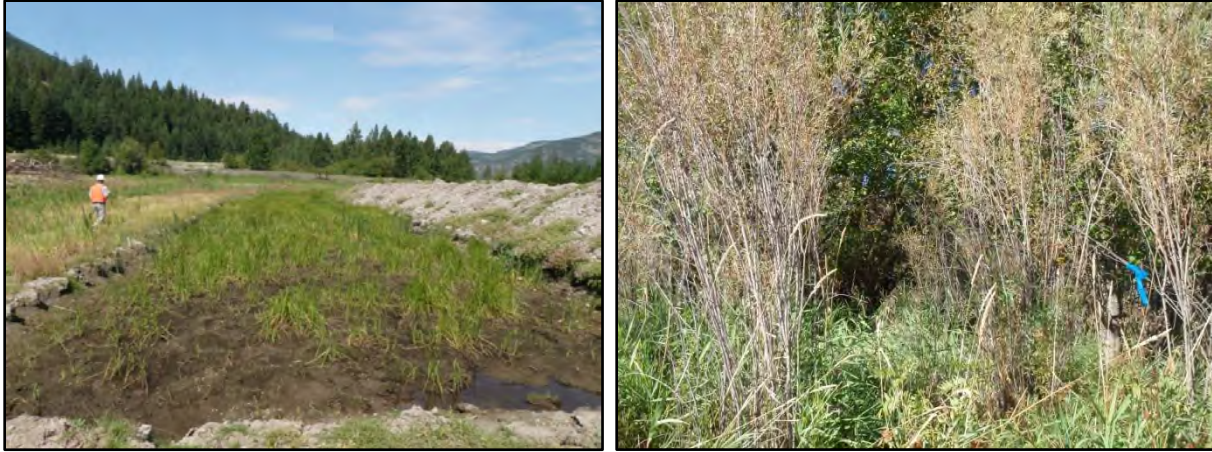
**Figure 9.** Photos of sod (left) and shrub (right) salvage staging areas.

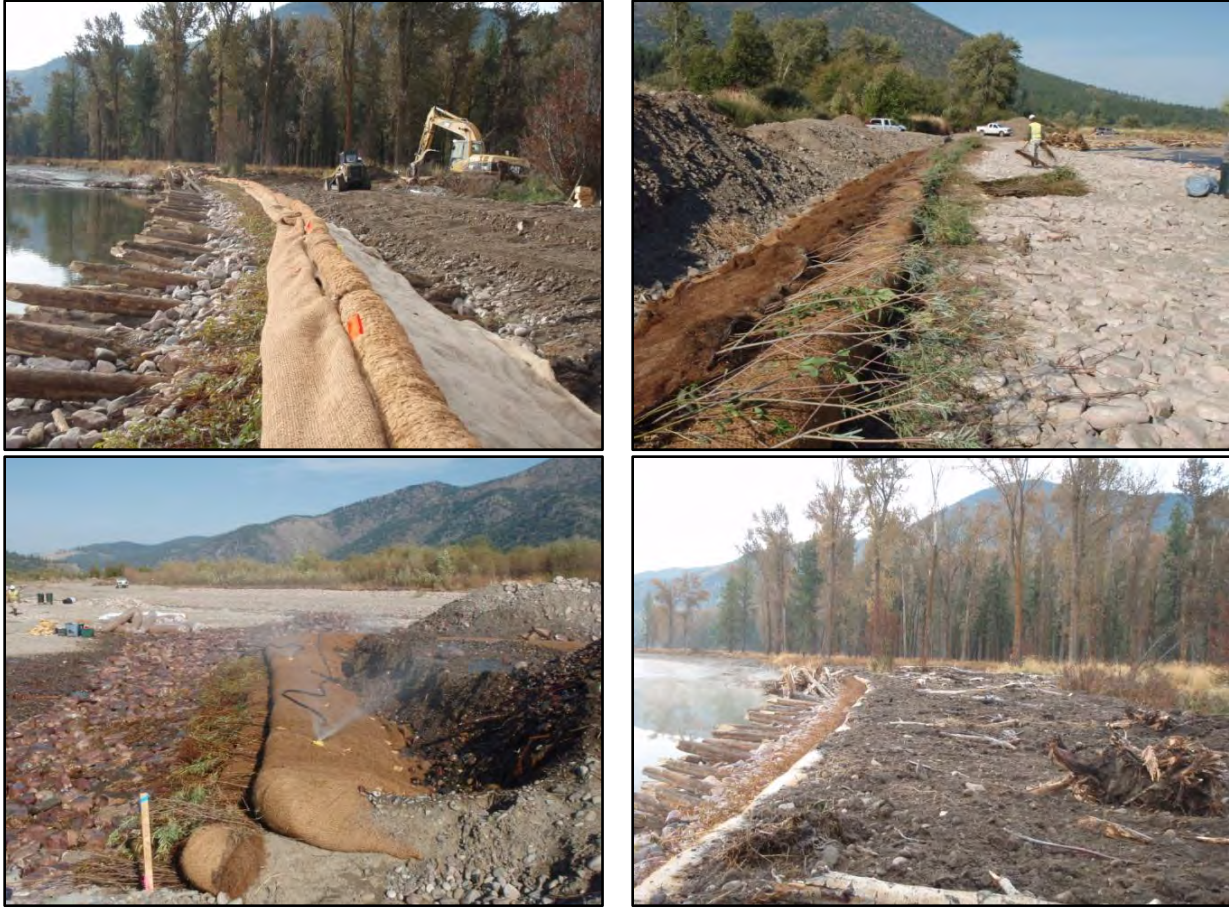
**Figure 10.** Photo series from left to right and top to bottom showing the construction of a vegetated soil lift.

Vegetated soil lifts (Figures 11 and 12) are a revegetation and bank construction technique that combines layers of dormant willow cuttings with fabric-wrapped soil to revegetate and temporarily stabilize streambanks. Soil is wrapped within two layers of biodegradable coconut fiber (coir) fabric, to hold the soil in place while vegetation becomes established in the relatively high stress land/water interface. The purpose of this treatment is to create site conditions directly along the channel that are suitable for growing riparian vegetation. While vegetated soil lifts provide some degree of bank stabilization, they are primarily a revegetation technique. They are installed on a wood and cobble toe, between woody debris jams, that together reduce bank undercutting and move the highest velocity flows away from the bank. Over a five to seven year period, the fabric will decompose and be replaced by dense, woody vegetation that will provide rooting strength sufficient to maintain low bank erosion rates.

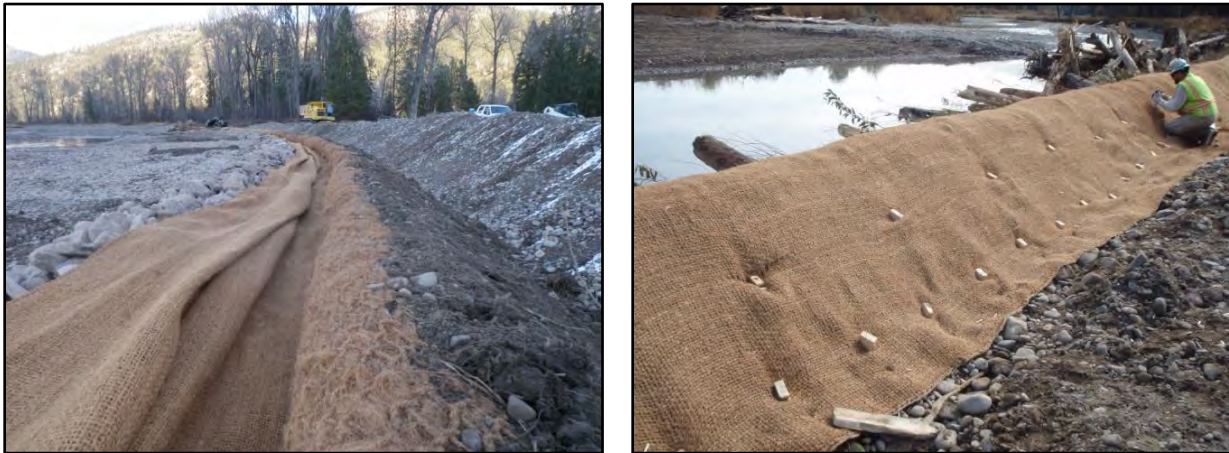
**Figure 12.** Construction of a wrapped coir log.

Coir logs are densely packed, cylindrical bales of coir (coconut fiber) encased in a synthetic (polyethylene) or natural (coir) mesh. The intent of the wrapped coir log treatment (Figure 13) is to provide temporary physical protection for the streambank, along moderate stress portions of outer meander bends (lower stress areas than where soil lifts are used), while vegetation becomes established and ultimately provides deep, binding root mass.

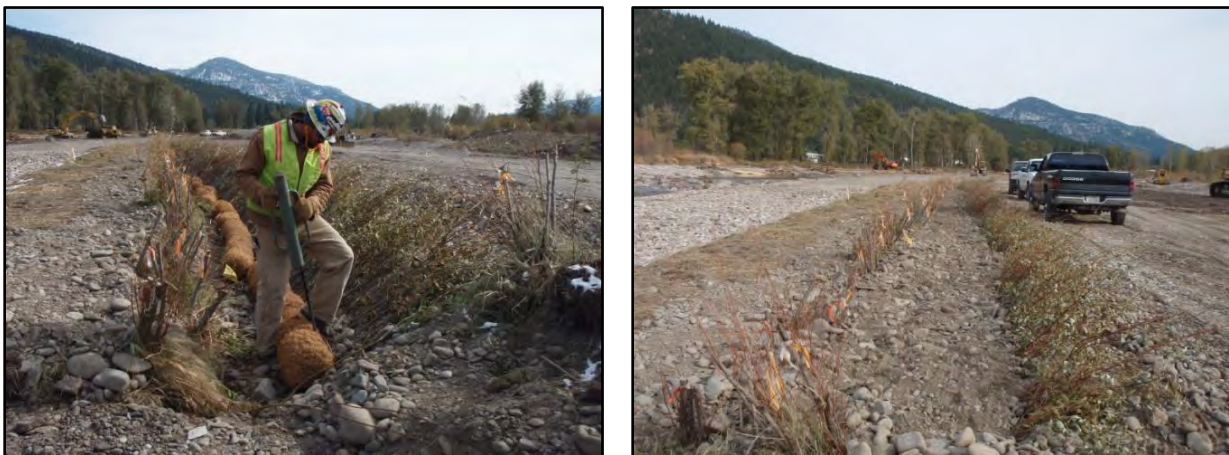
**Figure 13.** Construction of a vegetated brush trench.

The vegetated brush trench (Figure 14) is a revegetation technique used in association with placed sod along riffle and run features as they transition into inside meander bends. This treatment uses dormant willow cuttings to establish a dense row of vegetation along newly constructed streambanks. In addition, non-living brush materials incorporated into the brush trench provide floodplain roughness near streambanks to slow over bank flows and prevent erosion. During high flows, densely branching willows in the trench will trap sediments and native seed, and provide an environment for natural vegetation recruitment.

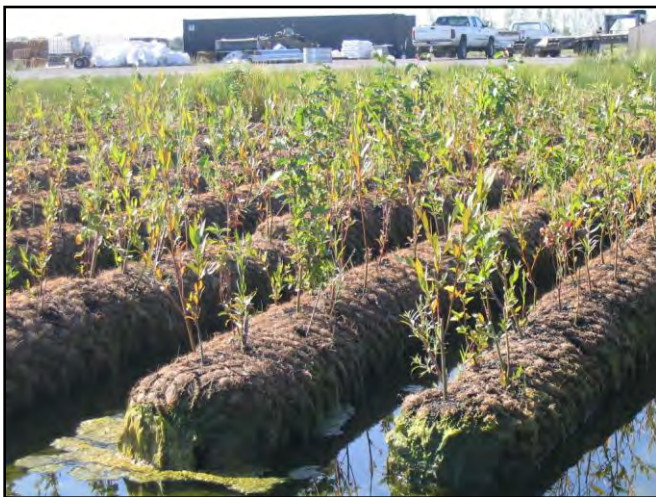
**Figure 14.** Photo showing pre-vegetated coir logs at the nursery during the first growing season.  
Seeding

Coir logs are densely packed, cylindrical bales of coir (coconut fiber) encased in a natural (coir) mesh. Pre-vegetated coir logs (Figure 15) are pre-planted with at least 30 willow, dogwood, or alder seedlings for each 10 foot length. The purpose of this treatment is to provide a stable, moist growing medium with mature roots, as a way to establish mature shrubs quickly in floodplain areas that might be susceptible to head cutting, within shrub establishment zones in wetland features, and along streambanks.

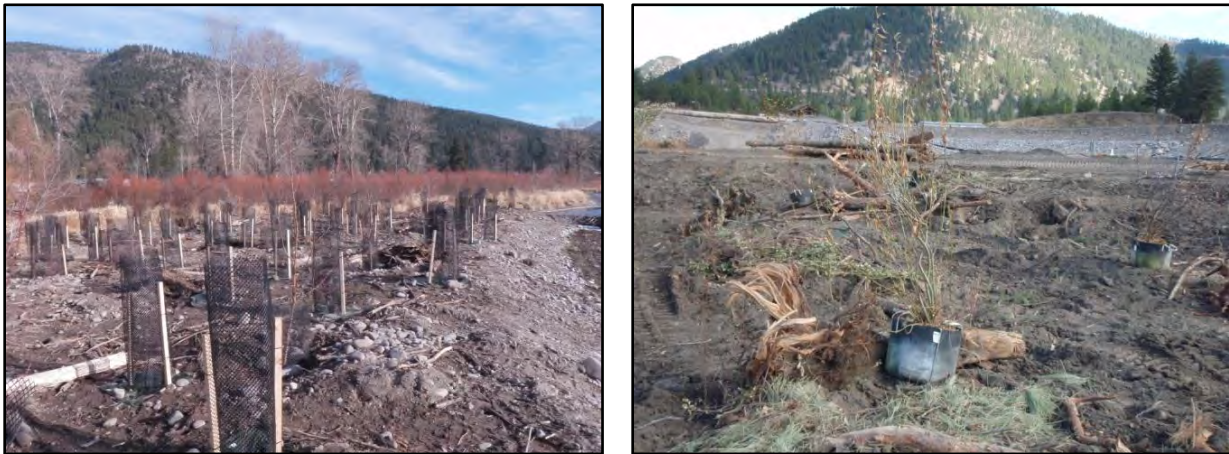
**Figure 15.** Containerized plants in browse protectors (upper left), and in grow bags (upper right)

Trees and shrubs will be planted in small clusters and in microtopography features throughout the floodplain (Figure 16). In mature cottonwood conifer and pole cottonwood and aspen vegetation cover types, planting will be concentrated in excavated swale features. In general, plant mixes include a mix of early-successional species, such as willows, alder, snowberry and rose, that may be better suited for the high light environment of the newly constructed floodplain surface. Species mixes also include some later-successional species, such as red-osier dogwood and Douglas-fir, in anticipation of the time when site conditions will favor these species. Plants are being grown in container sizes ranging from slightly less than one gallon to 16 gallon grow bags for trees and shrubs; and 10 cubic inch containers for herbaceous wetland species. Figure 17 shows the distribution of cover types and the quantity and type of plants for each planting area in the upstream portion of the restoration area.

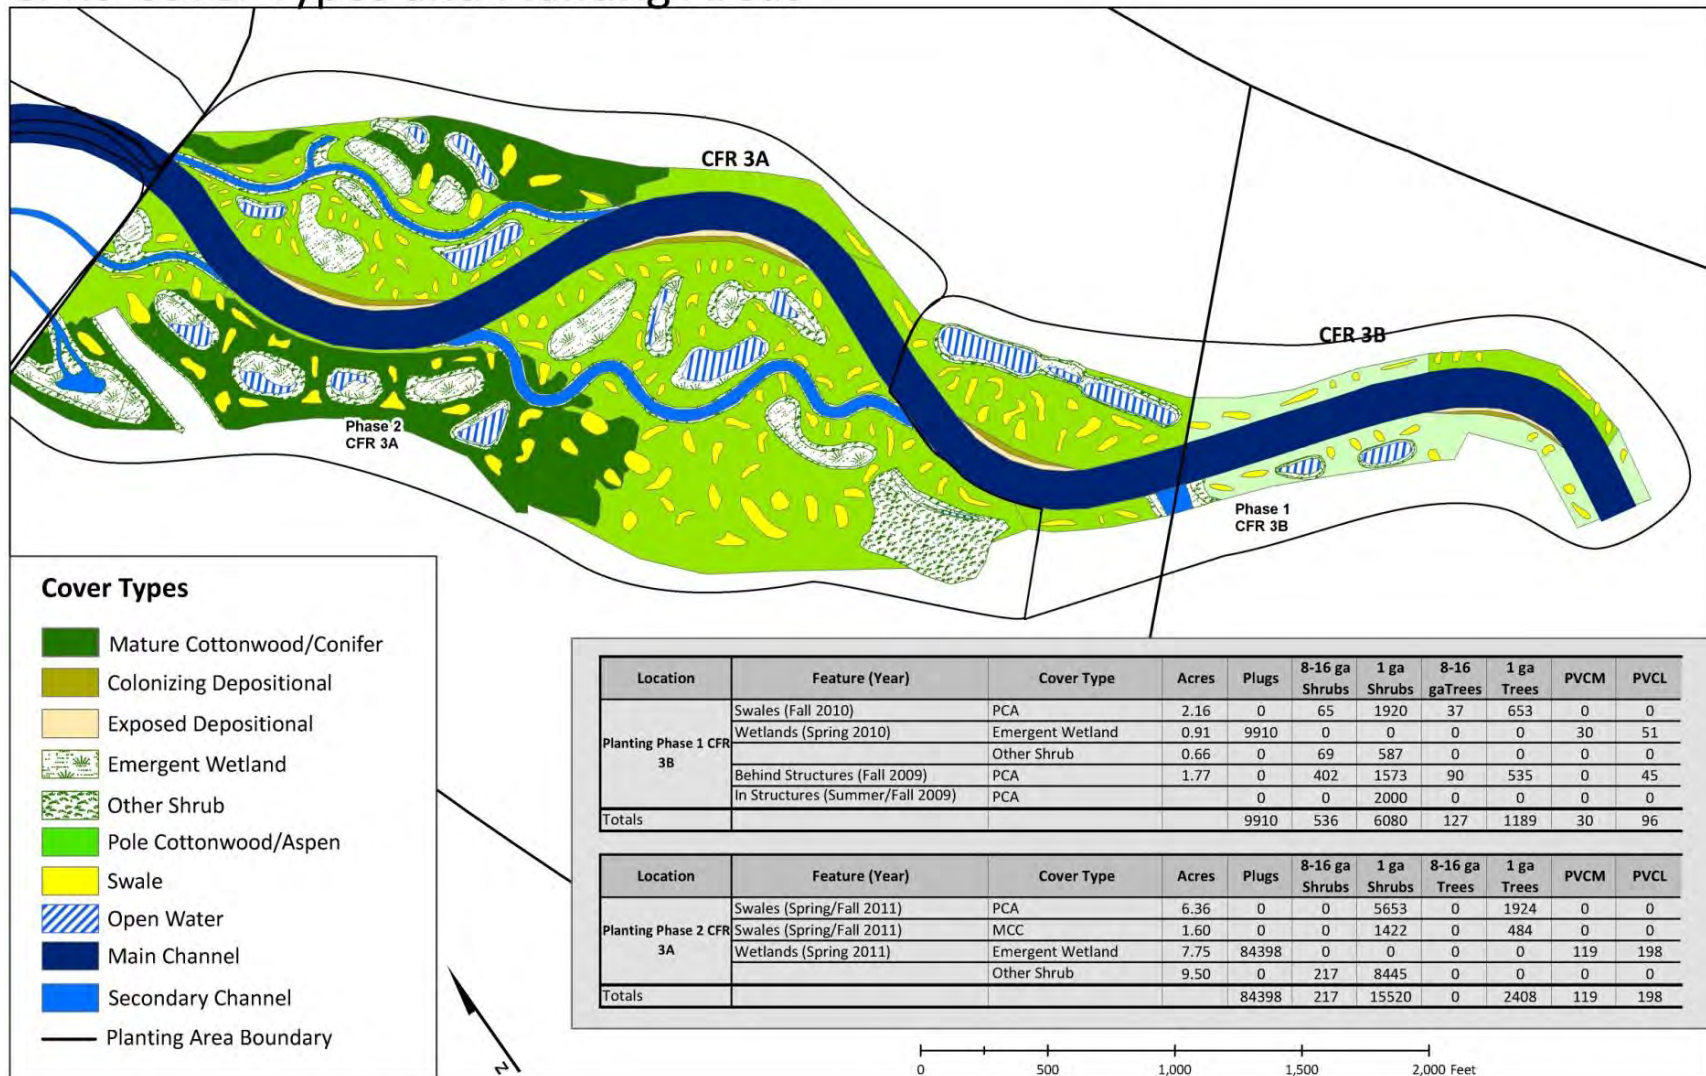
# CFR3 Cover Types and Planting Areas

**Figure 16.** Design cover types and example planting plan for the upstream portion of the restoration area (PCA=Pole Cottonwood/Aspen cover type and MCC=Mature Cottonwood/Conifer cover type).

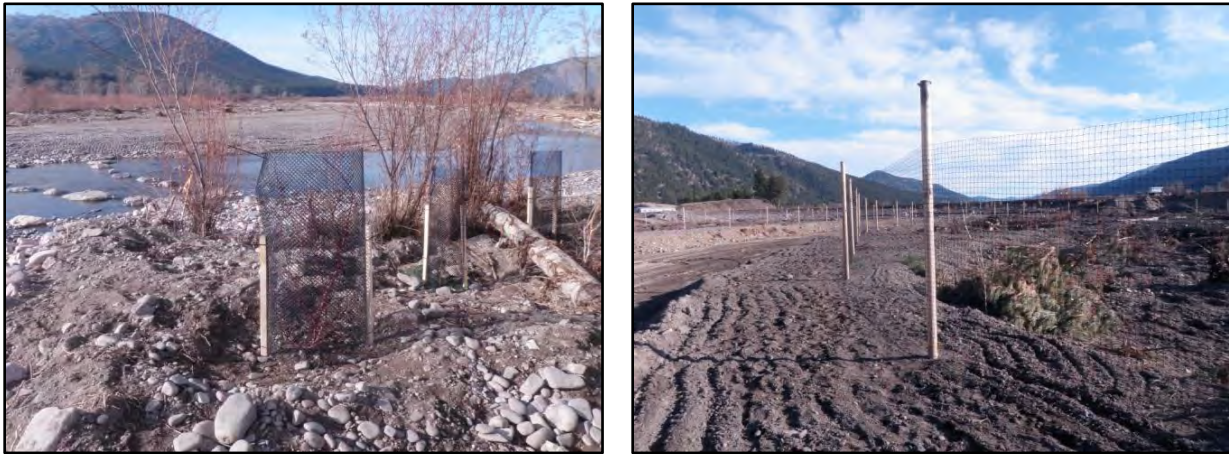
**Figure 17.** Photos showing examples of browse protection. Individual browse protectors (left) and planting area exclosures (right) were used in different areas depending on the planting unit size and location within the floodplain.

Elk, deer, beaver and other mammals are common in the restoration area and these animals may preferentially browse new shoots on planted material. In addition to installing containerized plants within swales where access by wildlife is more difficult; individual browse protectors and fences around planting polygons were used to protect plants from wildlife browse. Individual browse protectors made from rigid plastic mesh were secured around some plants and staked into the ground. Exclosures (8 ft tall) were constructed around selected groups of plants (Figure 18).

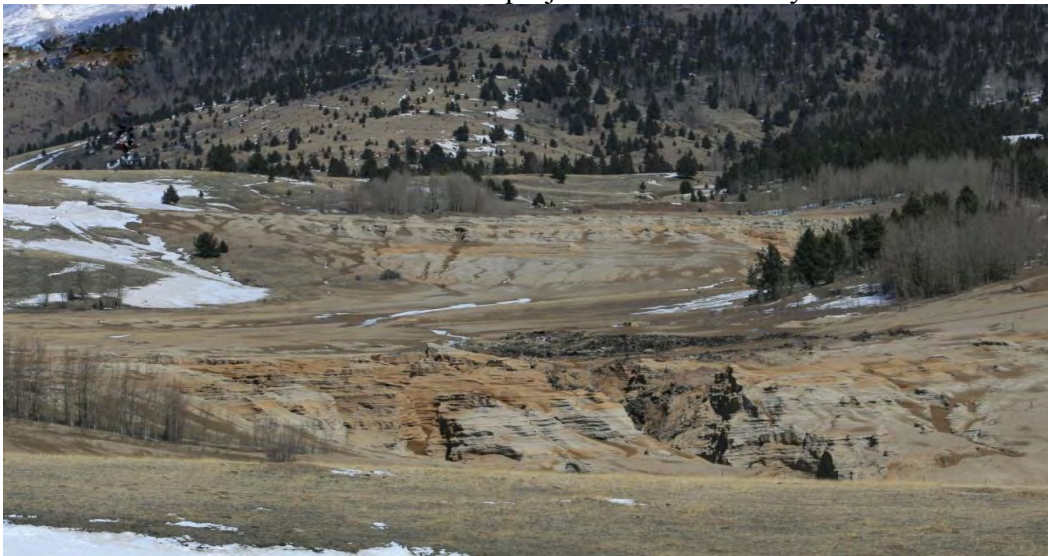
Figure 6, Millsap Mill Tailings **BEFORE**, March 7, 2007

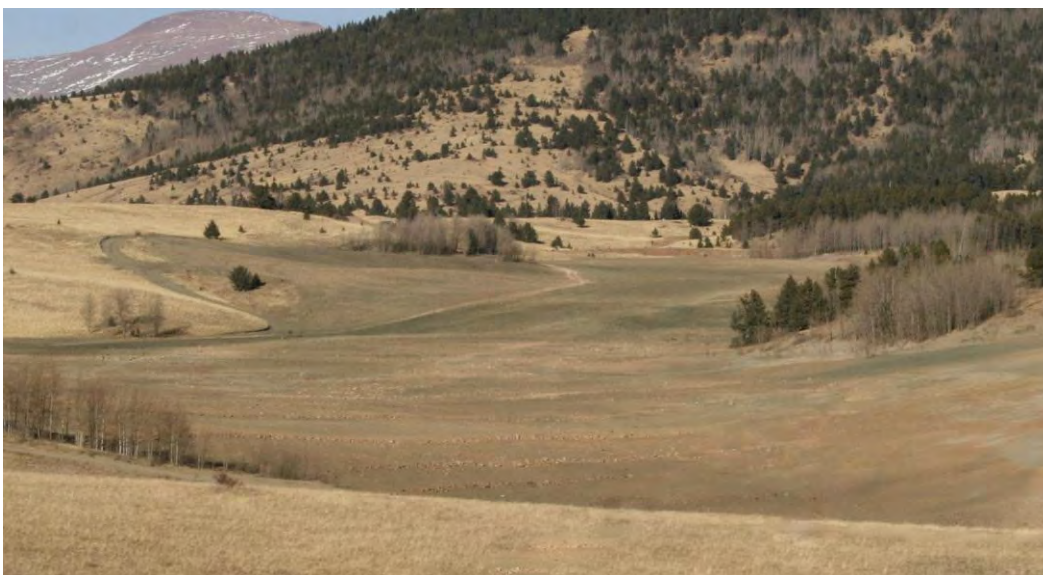
Figure 7, Millsap Mill Tailings **AFTER**, November 13, 2007

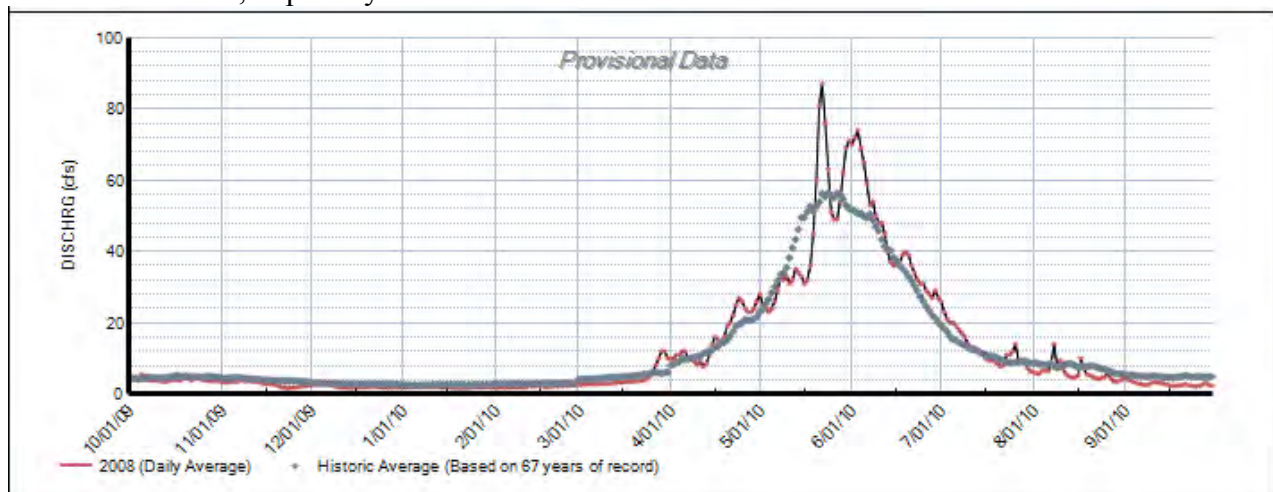
**Figure 3: Historic Daily and 2008 Daily Mean Streamflow of Kerber Creek.**

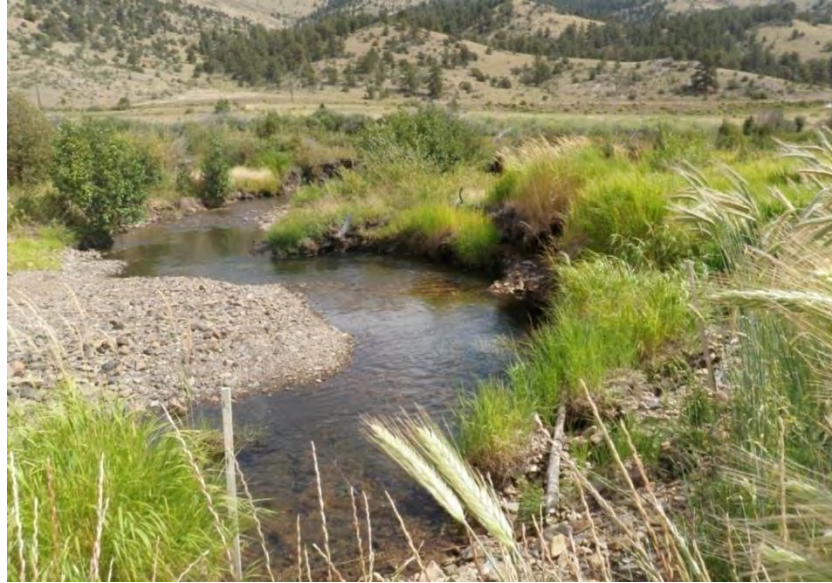
**Figure 8: A Highly Sinuous Stretch of Kerber Creek**

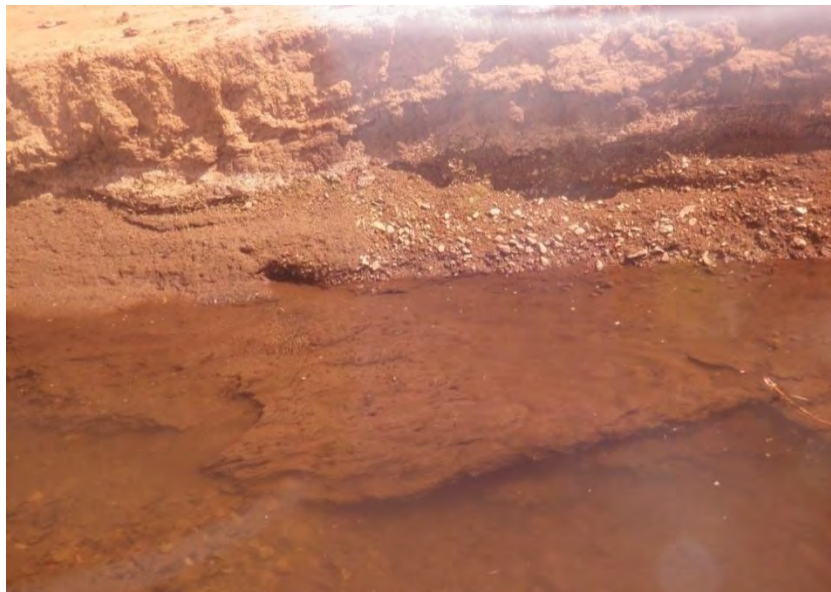
**Figure 9: Excessive Sediment Deposition in Kerber Creek**

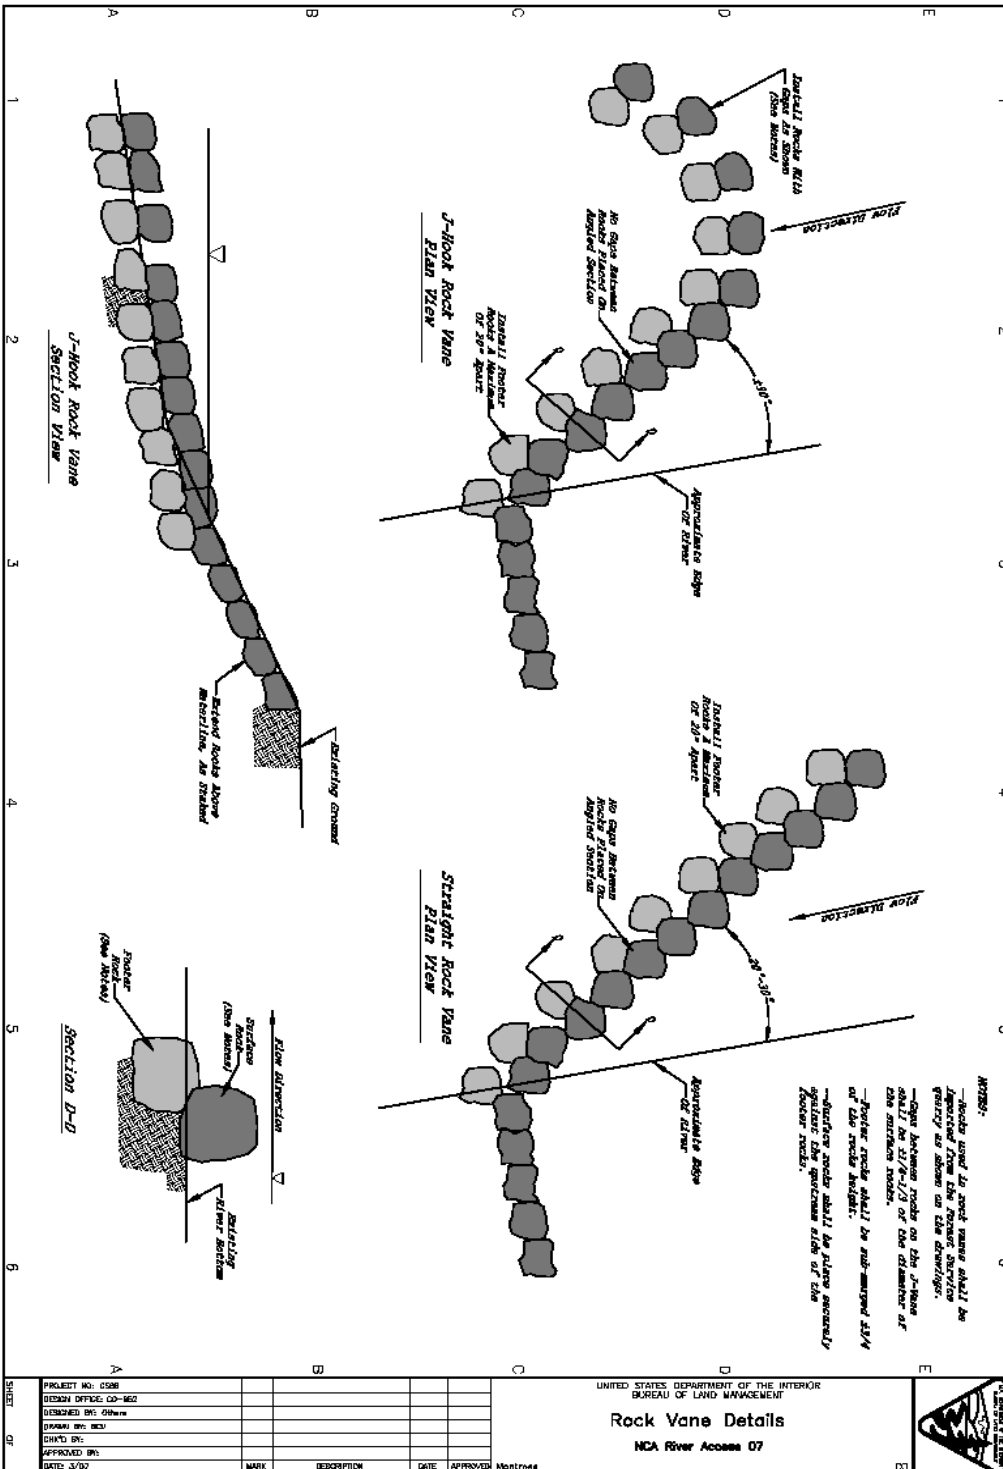
Figure 10: Specifications for J-Hook Vane Structures (Rosgen, 2006)

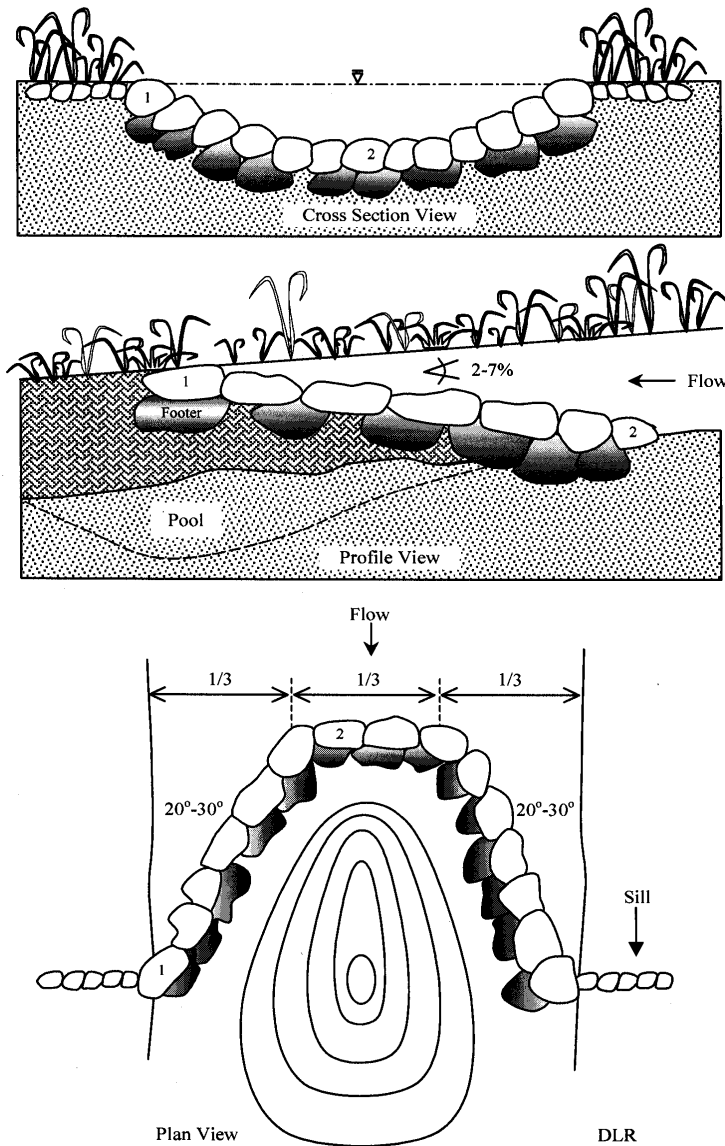
Figure 3. Cross section, profile and plan view of a Cross-Vane

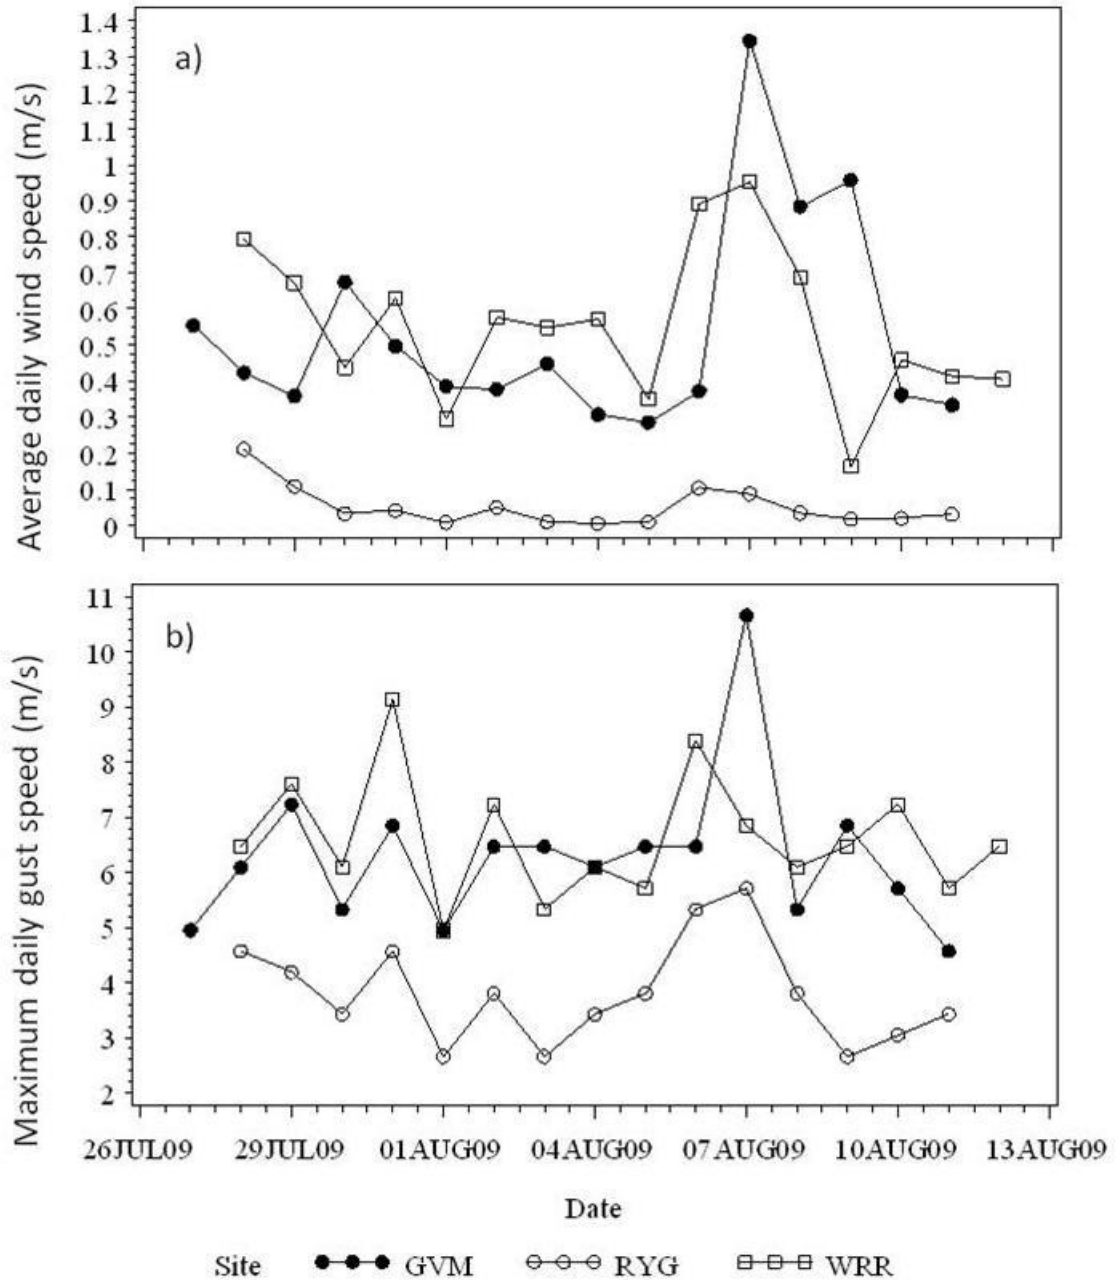
Figure 1. Average daily wind speed (a) and maximum daily gust speed (b) 30 cm from the ground surface at a mesa study site (GVM), a gulch study site (RYG) and a ridge study site (WRR).

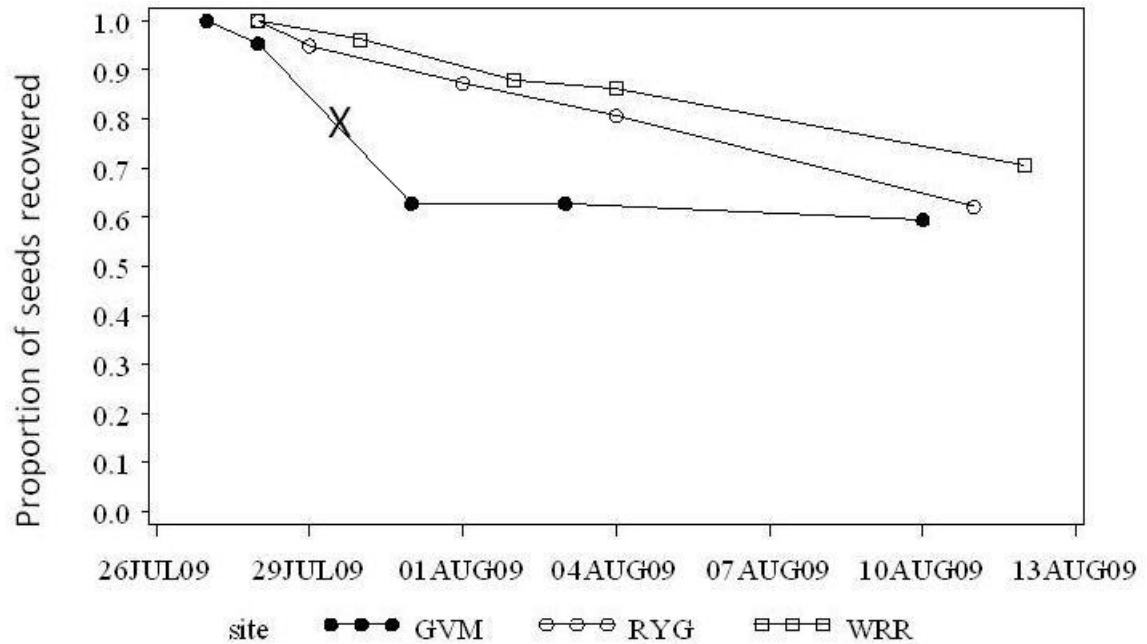
Figure 2. Proportion of released seeds recovered at three study sites. The first time point represents the release date. The X denotes a heavy rain event which occurred at the GVM study site.
