# **HIGH ALTITUDE REVEGETATION WORKSHOP**

**NO. 19**

**Colorado State University  
Fort Collins, Colorado  
March 2-4, 2010**

Information Series No. 113  
Colorado Water Resources Research Institute  
Colorado State University

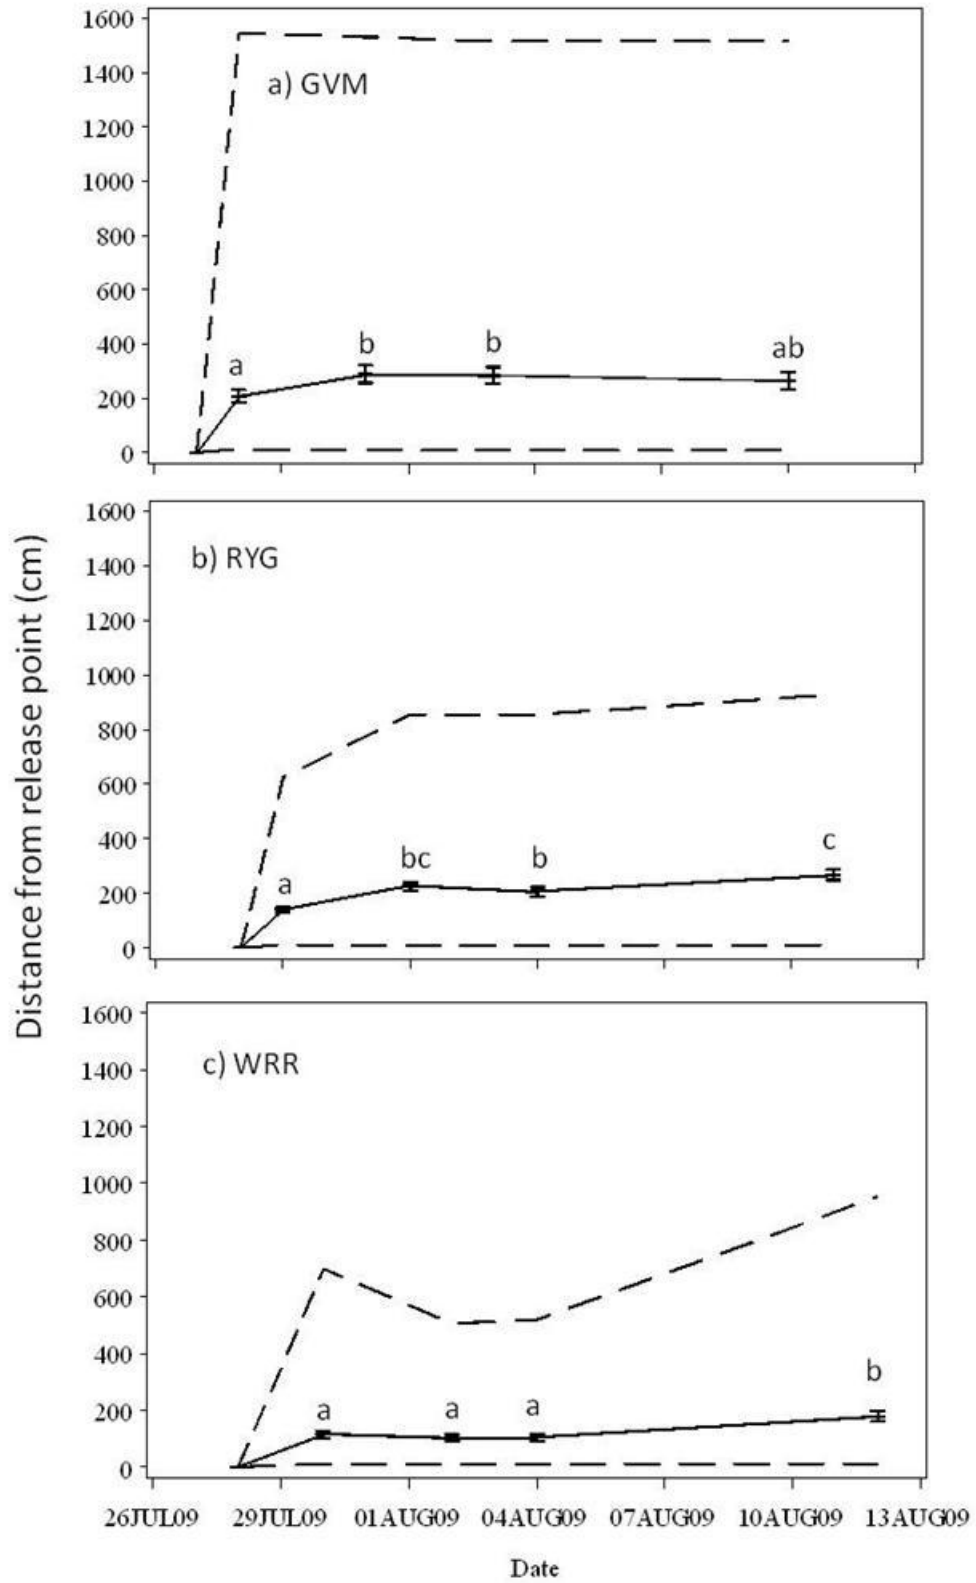
Figure 3. Dispersal of marked cheatgrass seeds at three study sites: a) Grand Valley Mesa, b) Ryan Gulch, and c) Wagon Road Ridge. Solid lines= mean distance from release point, dashed lines= 5% and 95% quantiles, error bars= SE. Time points not sharing letter represent significantly different means at  $\alpha = 0.05$ .

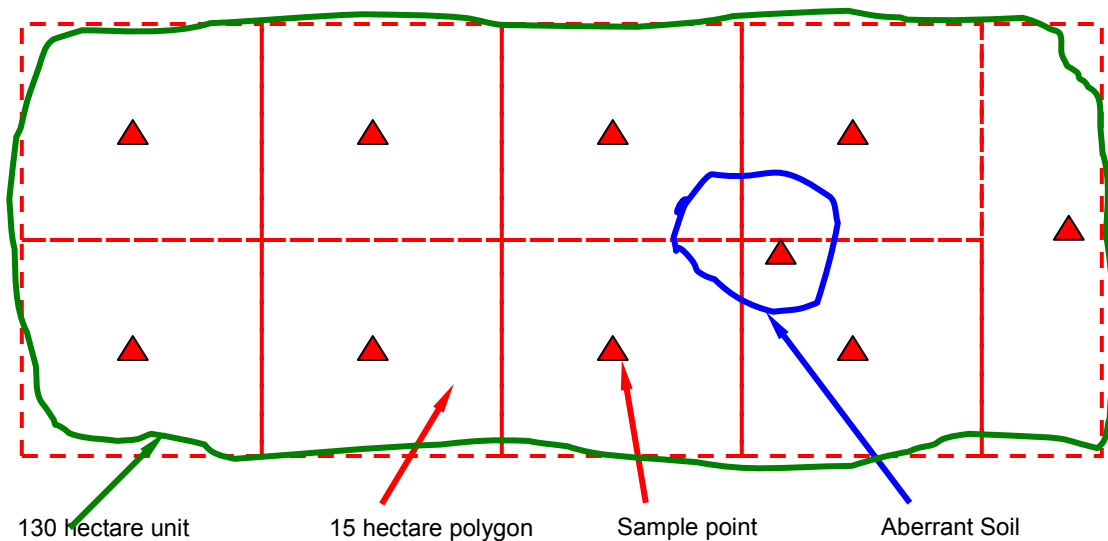
**Figure 2 - Example of a Systematic Grid Distribution for Sampling Growth Media**

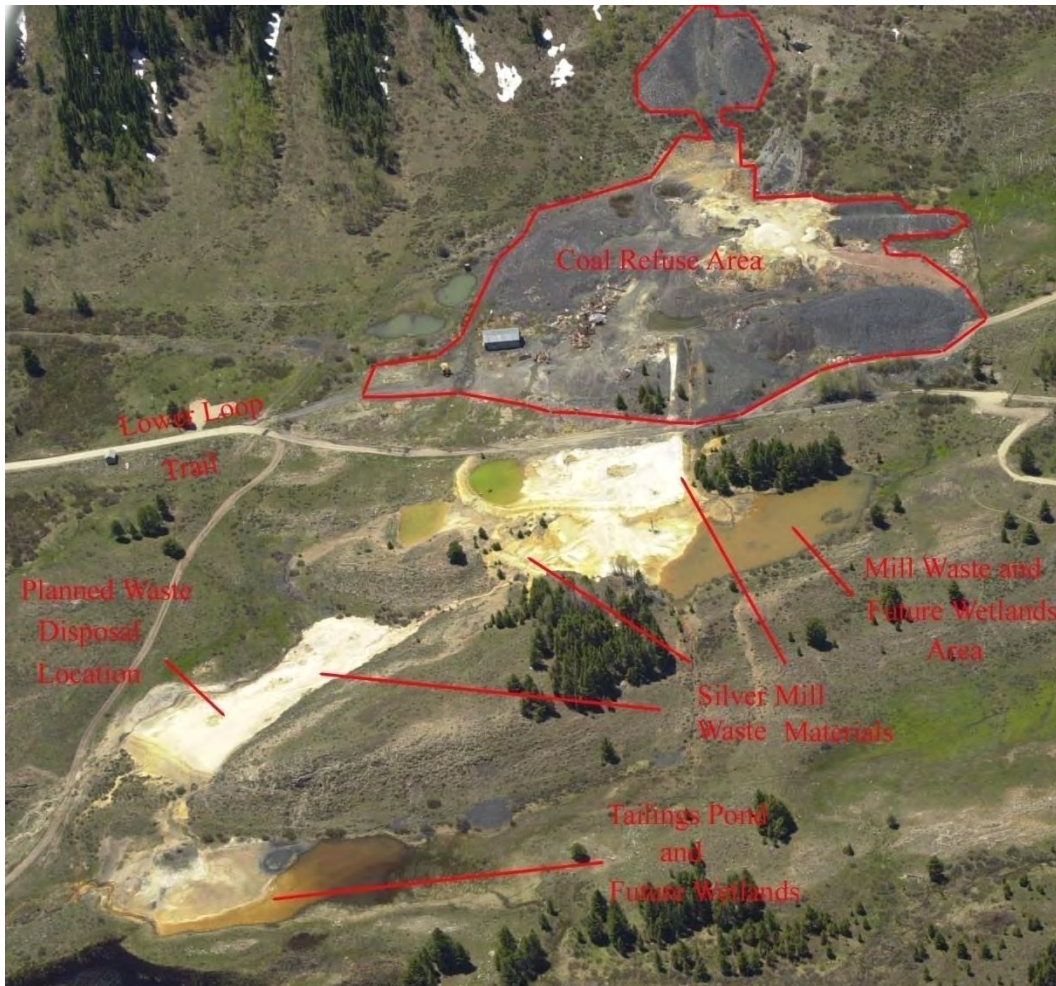
Figure 2. Aerial View of Sixteen Acre Peanut Mine Site, With Locations of Coal Refuse Materials and Silver Mill Wastes.

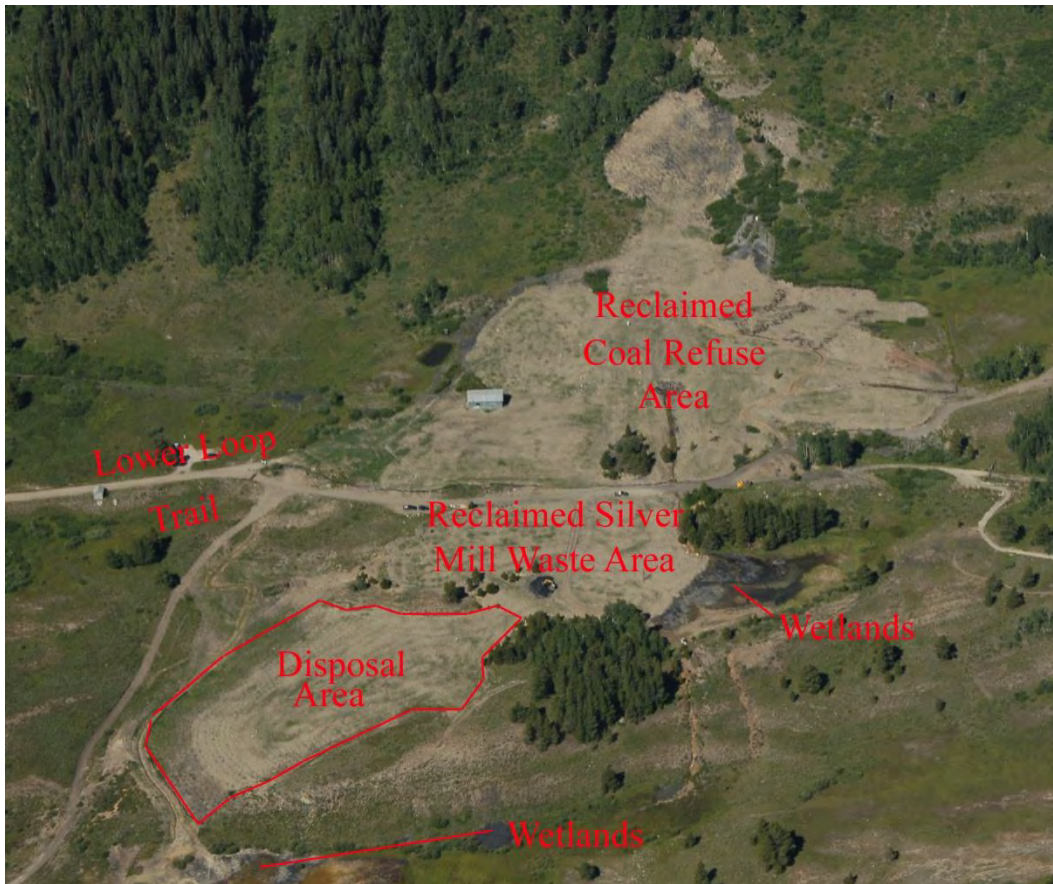
Figure 3. Aerial View of Peanut Mine, Early Summer Following Completion of Reclamation Construction.

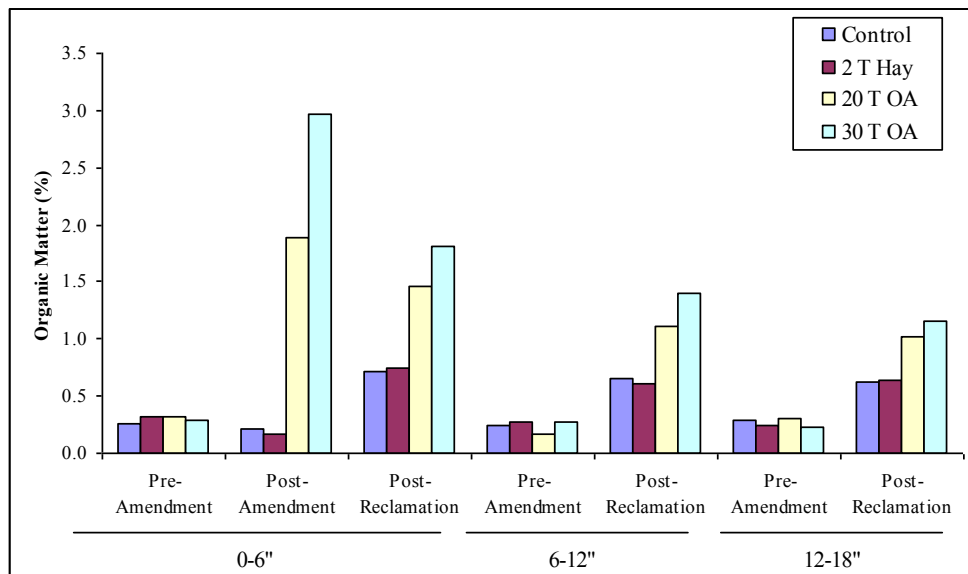
Figure 1: Organic matter interaction effect of soil amendment & year by depth

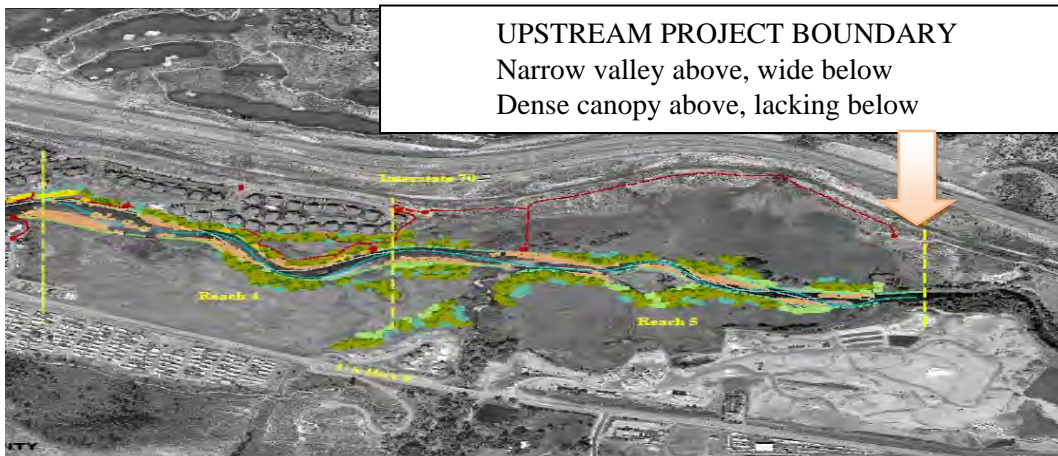
Aerial shows the abrupt widening of the valley as the river enters the Edwards Reach from the right side of the photo. The dense riparian canopy located upstream, but lacking through the reach, can also be seen.

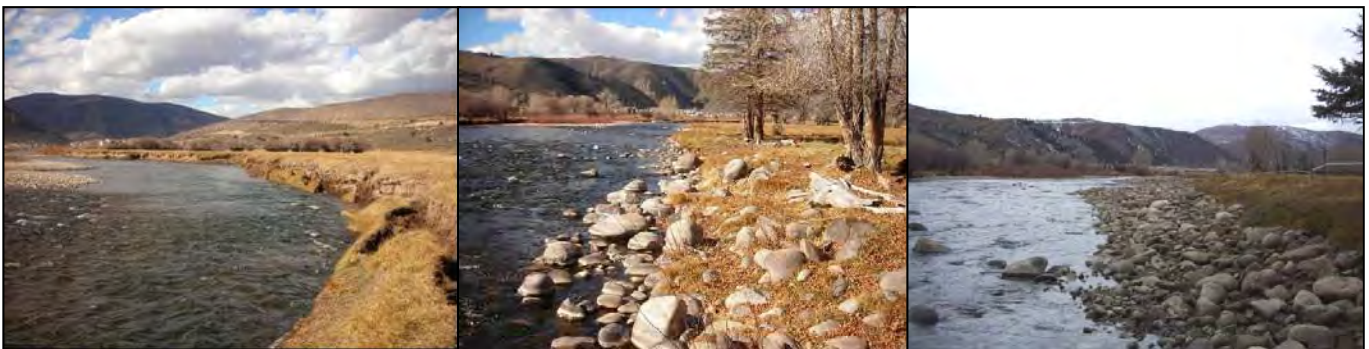
Photos illustrate, from left to right, typical degraded condition, target bank condition, and newly constructed condition.

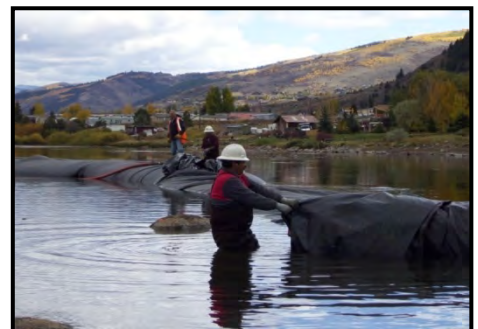
Aqua Dam installation is labor intensive.

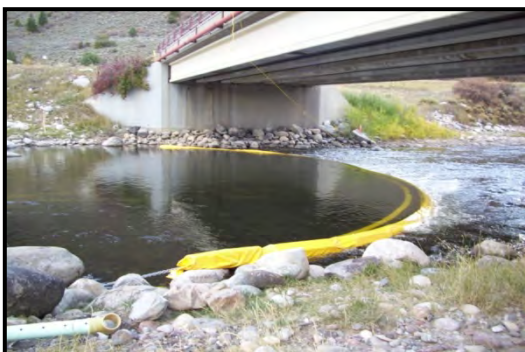
Stationary floating silt curtain installed at the downstream end of the project.

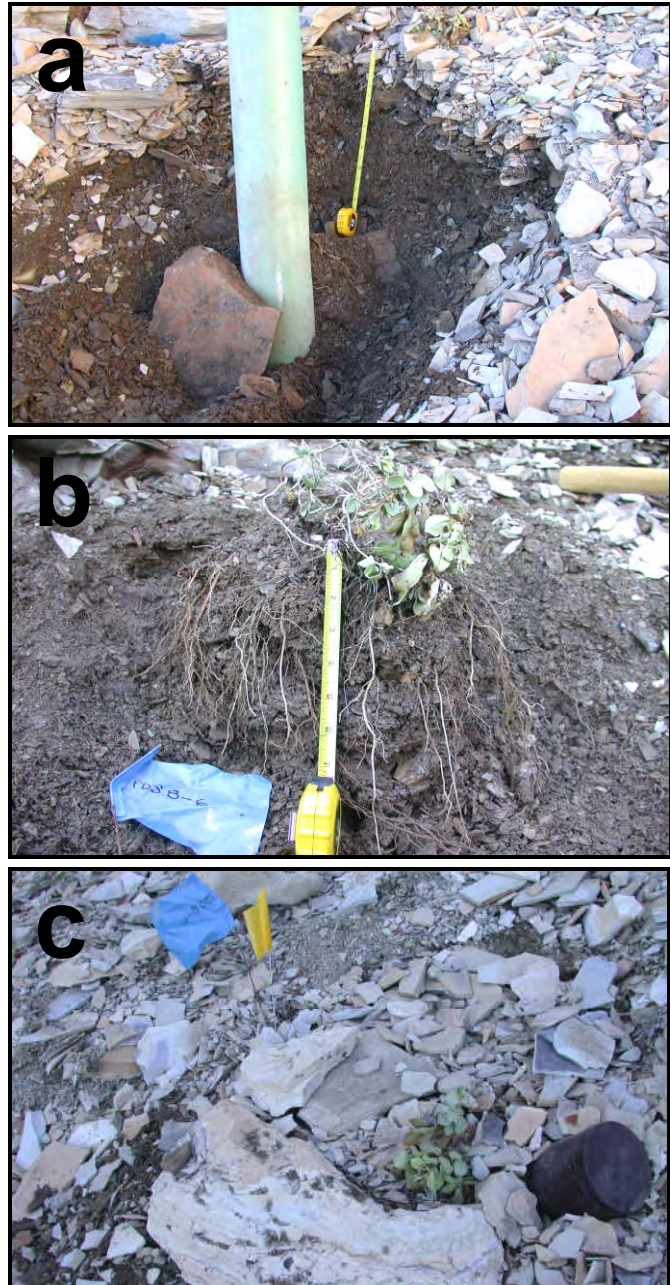
**Figure 3.** (a) Illustration of the extent of excavation required to remove some Parachute penstemon, and the use of a half-pipe to support a plant and root ball during excavation. (b) Some plants had an extensive root ball. (c) Newly transplanted individual along with its Dri-Water® access tube in lower right.

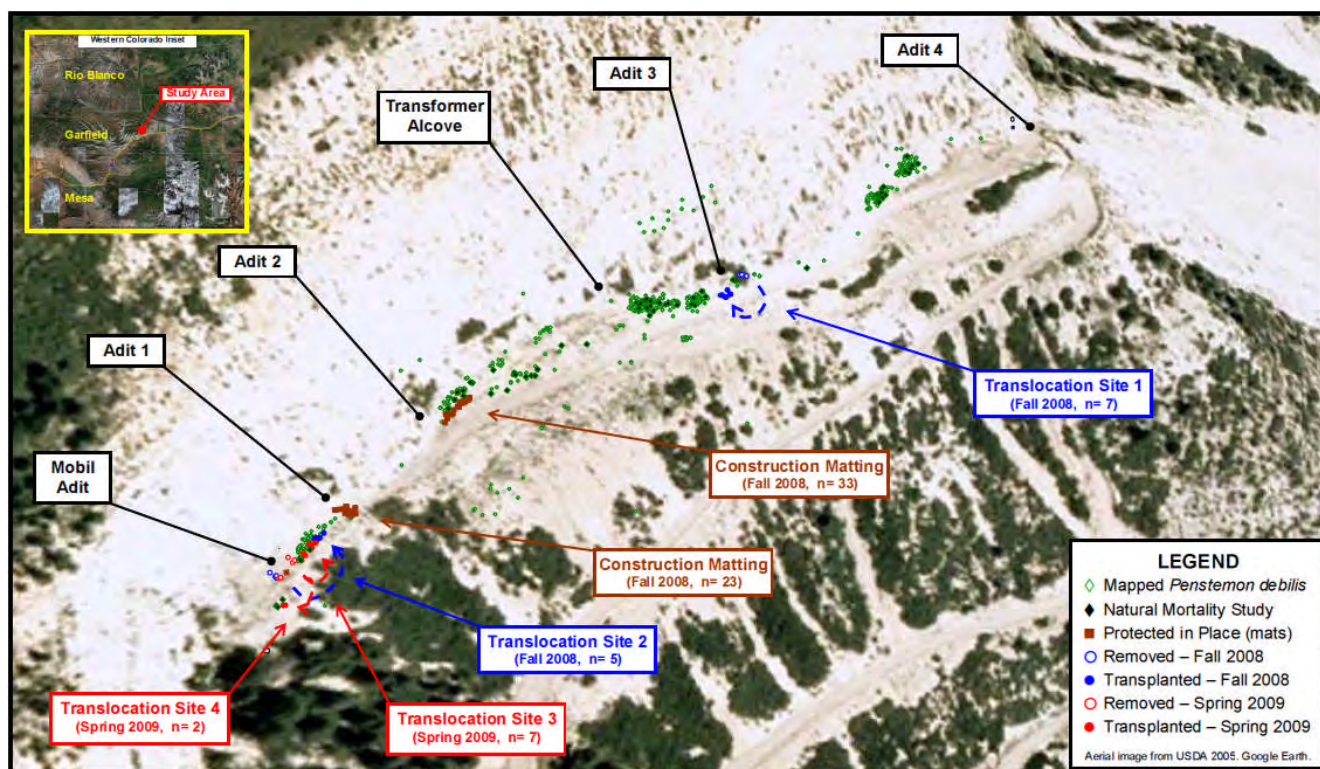
**Figure 4.** Locations of Parachute penstemon and other features on the Anvil Points Facility mine bench.
